Advances in Applied Science Research, 2011, 2 (3):574-585

## Application of Gis in Flood Hazard Zonation Studies in Papanasam Taluk, Thanjavur District, Tamilnadu

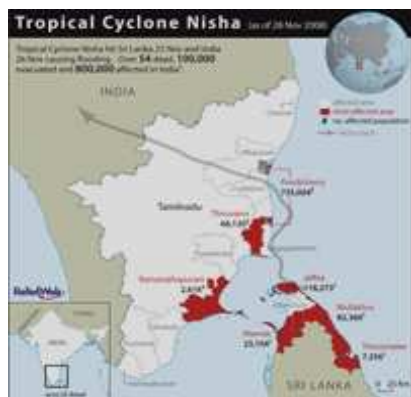
Fig 5.3 Track Cyclone of Nisha

Usually cyclone form between latitude  $10^{\circ}$  N and  $14^{\circ}$  N . In the earlier stages they move in a North – westerly or westerly direction. The cyclone disturbances are usually of high intensity. They form in the north Bay of Bengal and follows a west, north – westernly course. They do cause heavy rains and floods and strong winds. Terra satellite image taken from 26 November during cyclone season (Fig 5.3&5.4)

The cyclones tracks followed by the cyclone of NISHA in the Bay of Bengal (fig 1.3) The cyclones which form during the months April to May are called *pre- monsoon cyclones*. Those which form during the months October to December are called *post –monsoon cyclones*.

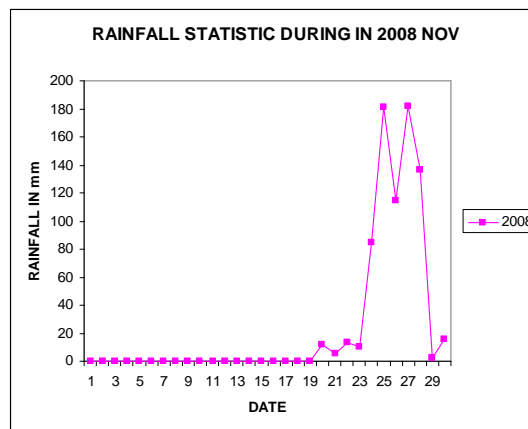
**Fig 5.5 Rain fall 2008.**

Rainfall amount 111.37mm average in the raining season. The hot season starts from March and heat subsides after June when water is let into the canals and southwest monsoon bring in showers. Maximum rainfall during November 2005 has occurred in the date 8 and 24. During the year November, 2008 maximum rainfall has occurred in the date 24 to 26. (Fig.5. 5)

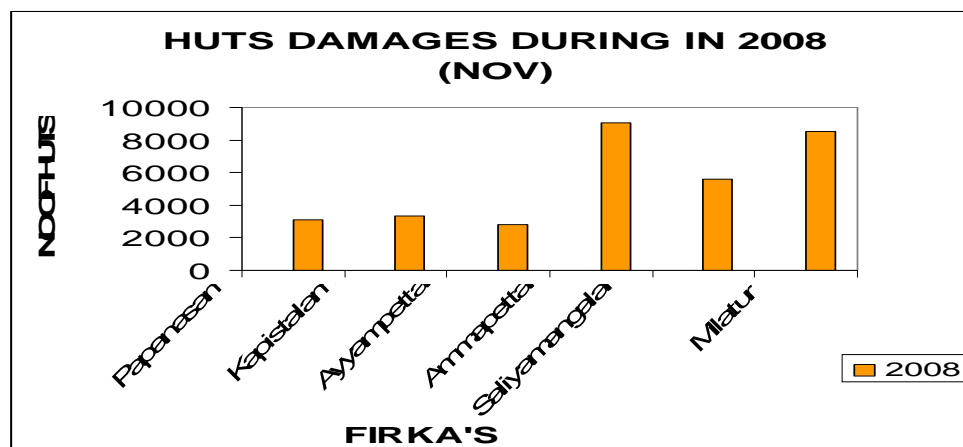
Fig.5.9. Huts Damages (2008)

Heavy damages in Ammapettai firka , Milatar firka about in fully damage about 10 , about 9,008 partly damages . Because low lying area in southern part of study area (fig 5.9 & 5.10).
