Complicated Cuffed Tunneled Hemodialysis Catheter Insertion in a Cardiac Transplant Patient

ABSTRACT

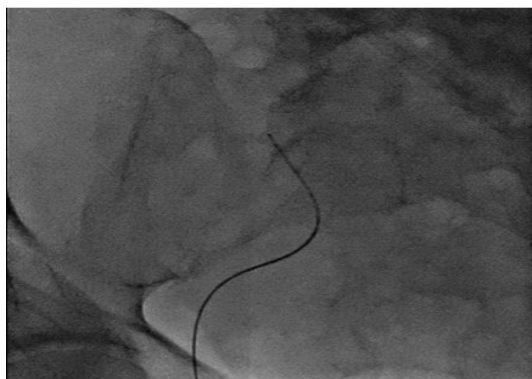
Figure 1: Guide wire through the Rt femoral vein.

With real time ultrasound and fluoroscopy guidance, the Rt. femoral vein was punctured after skin preparation, sedation and local anesthesia. The guide wire was introduced but there was resistance encountered at 25 cm. The location of the guidewire, as indicated by fluoroscopy, was deviated laterally at the lumbosacral disk L4-L5 level (Figure 1). We were unable to reposition it properly to the IVC despite attempts to retrieve, rotate and slide the guidewire. We did not want to use contrast in view of his clinical condition. The guidewire and the needle were retrieved (Figure 2).

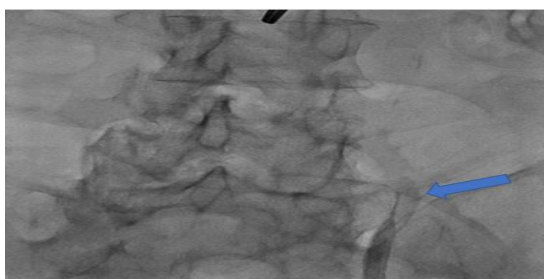
Figure 2: Sliding a catheter over the guide wire from the Lt femoral vein.

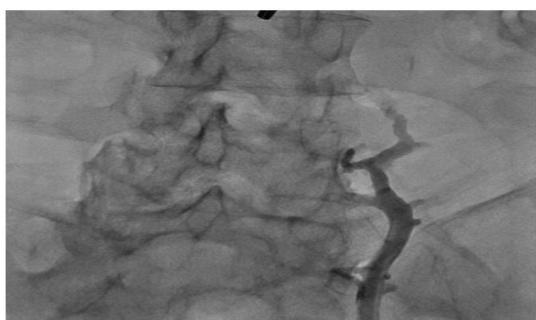
Figure 3: Starting injecting contrast through the catheter.

The Lt. femoral vein was punctured, as an alternative site, with real time ultrasound and under direct fluoroscopy, but we faced the same scenario. The guide wire was located laterally and did not proceed beyond 25 cm. At that point we elected to use Iodine contrast to delineate the venous system anatomy before proceeding further. A venous plexus was illuminated draining from the Lt. common iliac to the lumbar region with multiple tributaries (Figures 3 and 4). The catheter was retracted 2 inches and a second contrast dose was injected the Lt (Figure 5). Common iliac and the IVC were clearly visualized this time [3]. The total contrast dose was 35 ml. Double hydrophilic guide wires were passed, with some manipulation, through the Lt. Common iliac vein with the tips at the IVC.

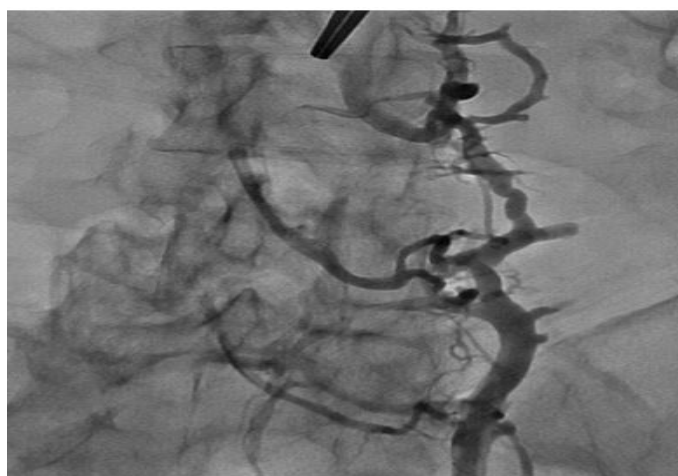
Figure 4: The full venous tributaries after the full injection of the contrast.

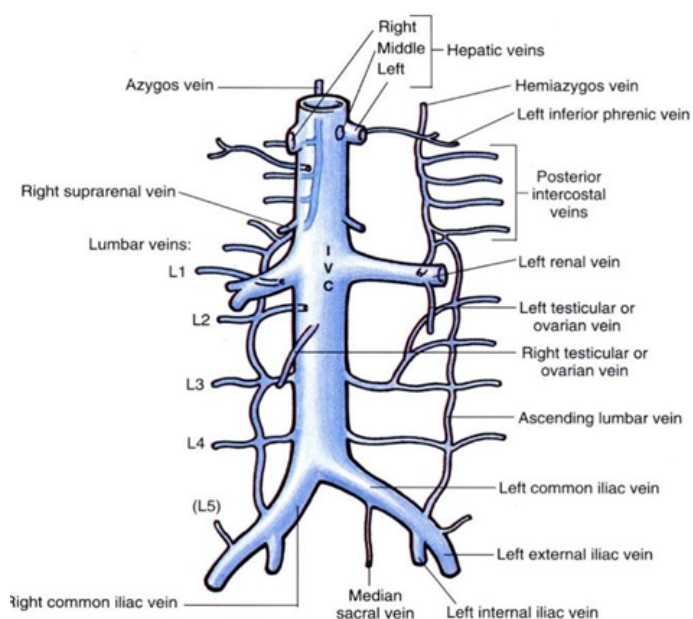
Figure 5: The lumbosacral veins on the Rt. and Lt Side with the tributaries.

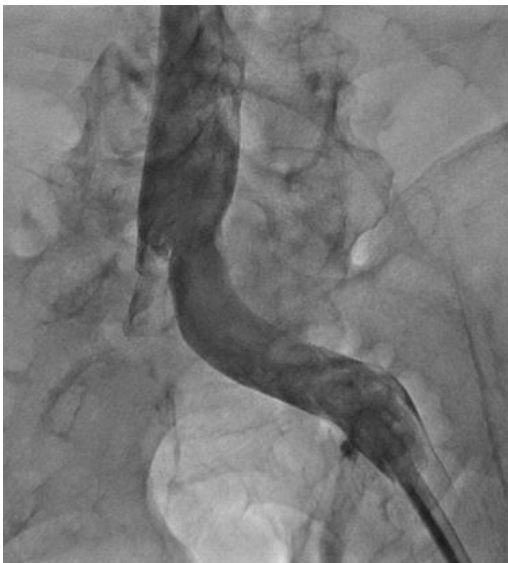
Figure 7: Contrast injected after withdrawal of the catheter by 2 inches.

The position was confirmed with fluoroscopy using Iodine contrast, (Figures 6-8). A cuffed tunneled catheter was

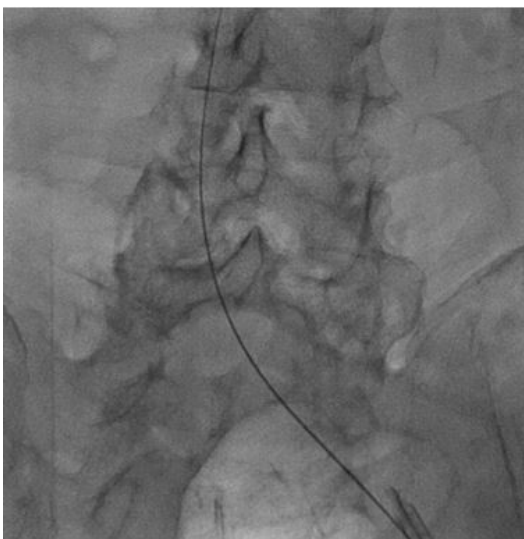
Figure 8: A guide wire introduced through the catheter to the IVC.

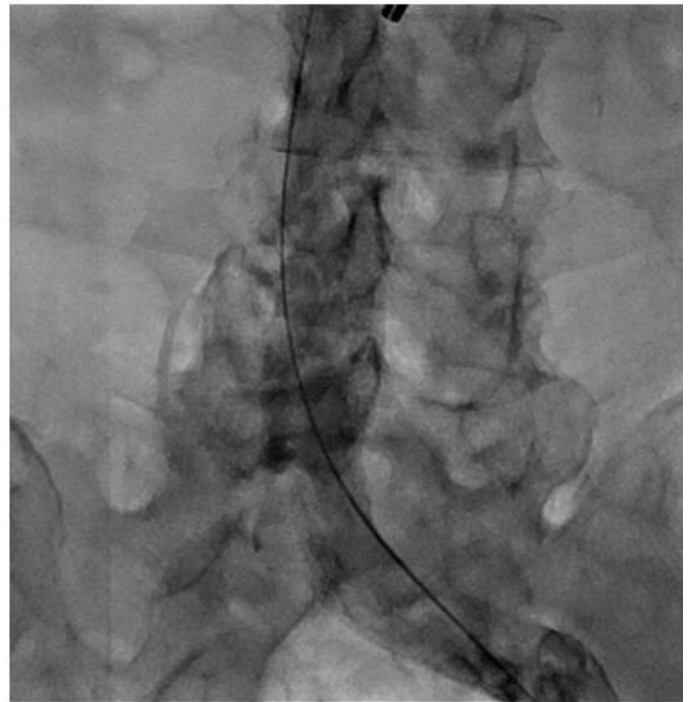
Figure 9: Post guidewire introduction in the IVC with contrast to confirm the position.

guided with rotation and manipulation under fluoroscopy over the guidewires to the IVC (**Figure 9**). The position was confirmed with fluoroscopy and the guide wires were retrieved (**Figures 10 and 11**). The blood flow was checked from both venous and arterial lumen [4]. Heparin lock solution was placed. The catheter was sutured to the skin and the wound was closed. Proper dressing was applied. The patient was stable through the procedure, with no complications.

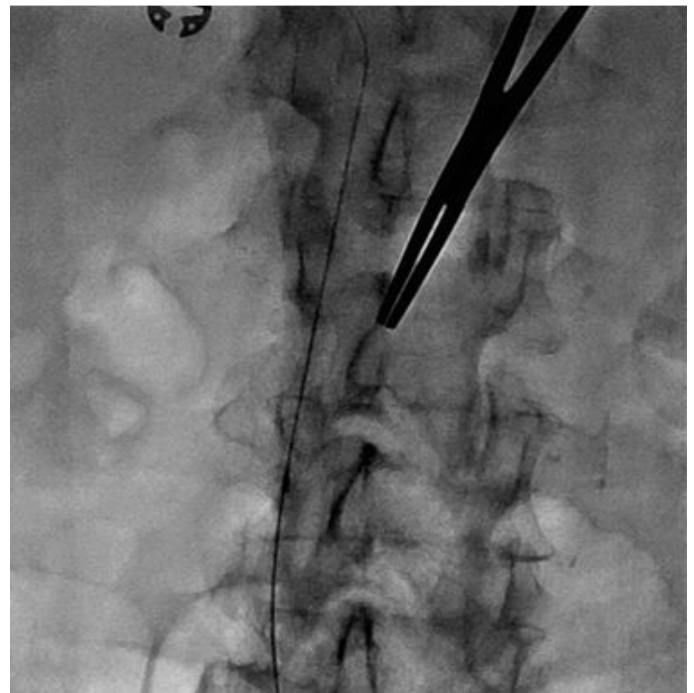
Figure 10: Tracking the tip of the guidewire.

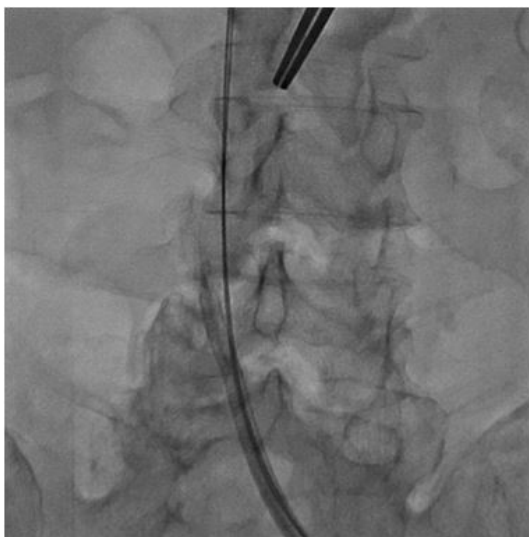
Figure 11: Sliding the catheter over the guidewire to the IVC after inserting a second guide wire.

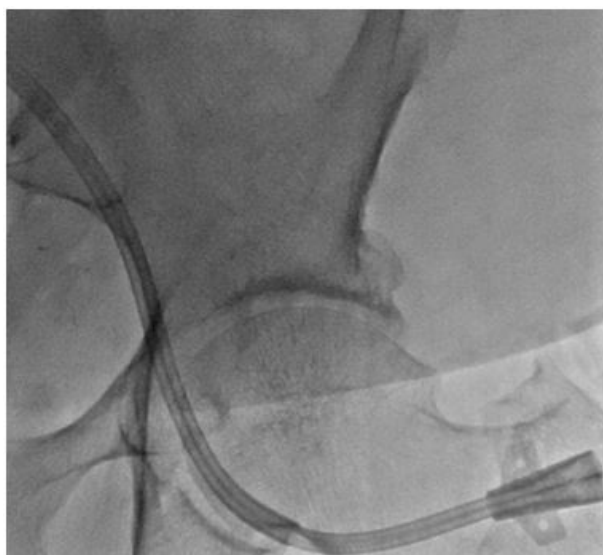
Figure 12: The catheter course after removing the guidewires.

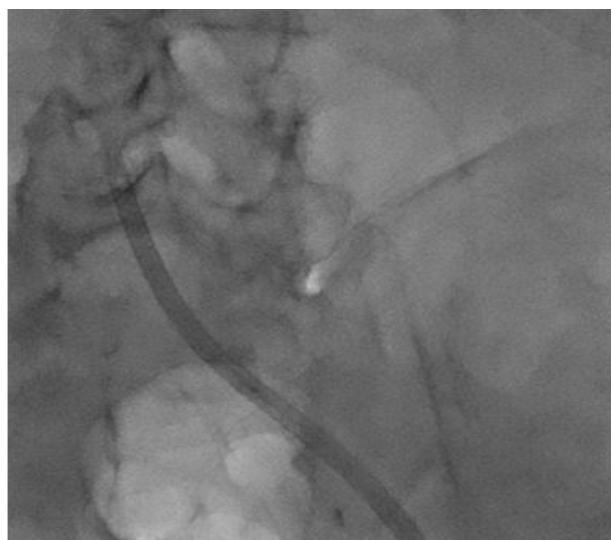
Figure 13: The catheter tip after removal of the guidewires.
