Assessment of riparian buffer zone of Chandni Nalla-A stream in Narmada Basin, India

Sajjad Ahmad War, Ankit Kumar and Vipin Vyas*

Department of Environmental Sciences and Limnology, Barkatullah University, Bhopal, India

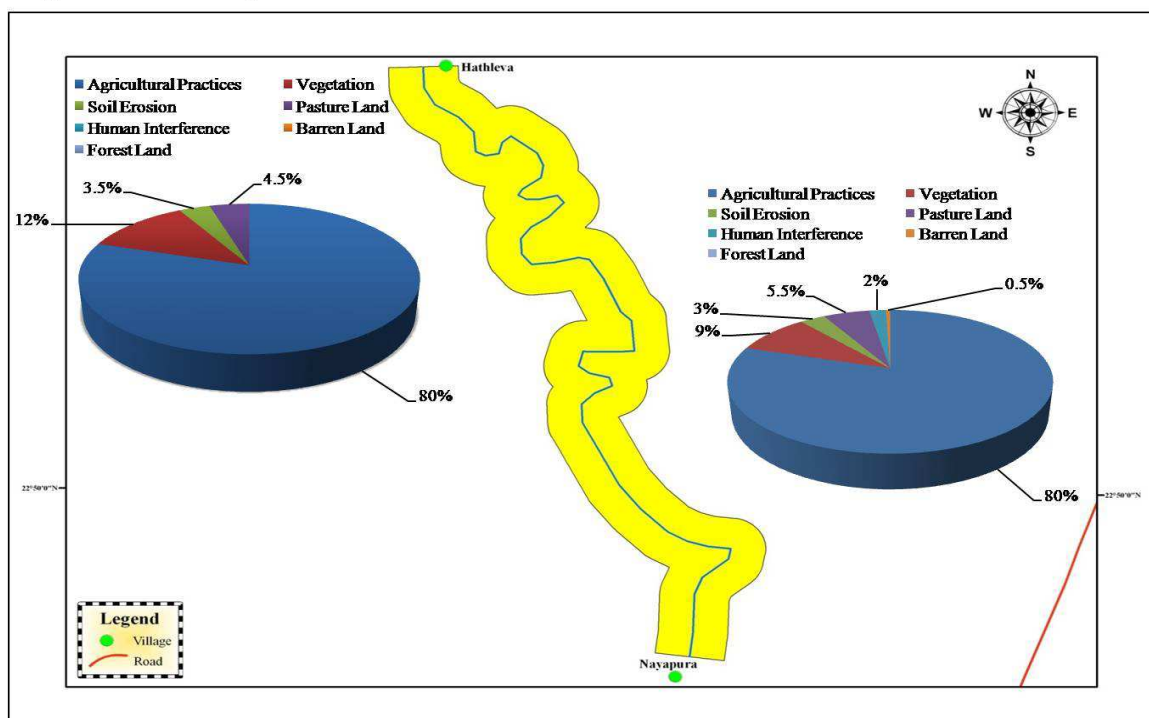
Figure- 5: Status of riparian buffer zone in section- 2

Section- 2: This section of the study area starts from the village Hathleva and lasts till Nayapura. Mean channel width in this section was recorded 11.3 meters while full stream width was recorded 35.5 meters respectively. During the study, at left bank agricultural activities was found in dominant condition which covers 80% while vegetation covers 9% of the total area whereas, barren land covers least area of 0.5%, meanwhile no forest land was observed in this section (Figure- 5).

On the right bank, agricultural activity was found in dominant condition which covers 80% while vegetation covers 12% of the total area. Meanwhile, forest land, barren land and human interference were absent (Figure- 5).

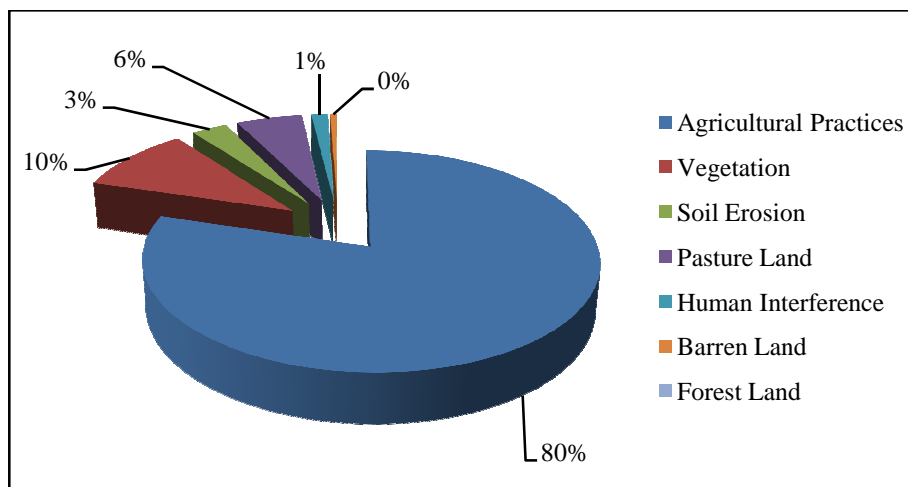
Figure- 7: Overall status of riparian buffer zone on the left bank

Overall status of left bank- Observations made after a long extensive survey it was found that agricultural practices are in dominant position on the left bank of Chandni Nalla which covers 80% of the total area whereas vegetation land covers 10%, meanwhile forest land was absent on this bank (Figure- 7).

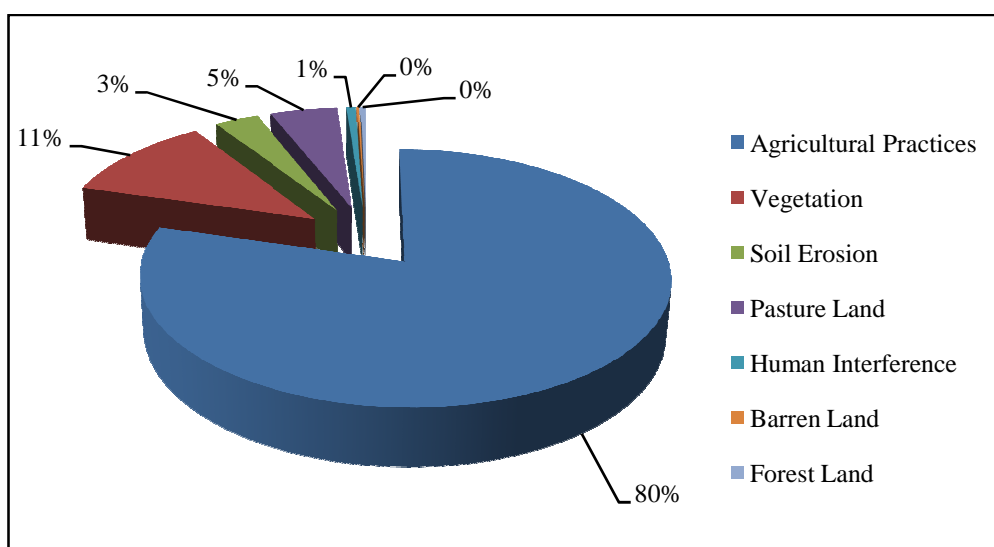
Figure- 8: Overall status of riparian buffer zone on the right bank

Overall status of right bank- Almost same situation was recorded on the right bank of Chandni Nalla where agricultural practices was found in dominant condition which covers 80% of the total area while vegetation land covers second position with 11% of total area and other parameters cover least position in the area (Figure- 8).
